Dynamic characteristics of tailings reservoir under seismic load

Keywords Tailings reservoir · Seismic load · Dynamic characteristics · Shaking table test · Numerical calculation

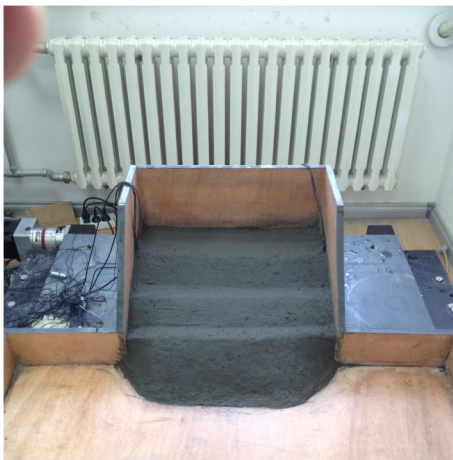
Fig. 2 Front view of model box after stacking

In the process of dam filling, the pin was buried in the tailing sand at a certain distance, and the coordinates of each mark point were recorded. All test instruments were opened, the output acceleration of the shaking table was controlled, and the water level of the piezometric tube was recorded. The front view of the model box after the completion of the stacking dam is shown in Fig. 2. With consideration to seismic response analysis, horizontal waves play a major role in earthquake engineering; therefore, this experiment provided a horizontal seismic wave as a dynamic load input through the shaking table (Fig. 3). Additionally, the selected seismic wave was filtered and the baseline processing was corrected

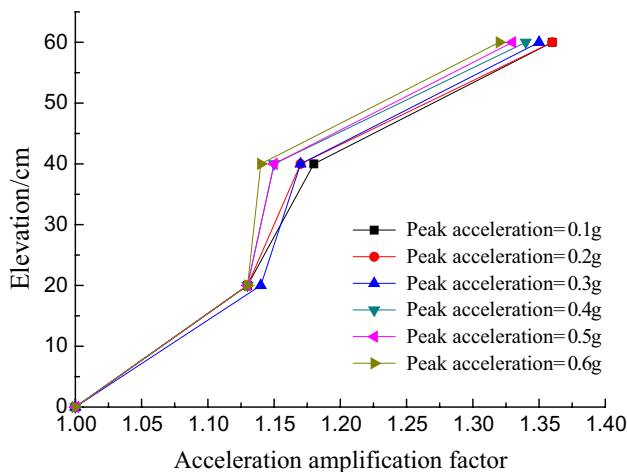
The vibration acceleration response was obtained from the acceleration sensor embedded in the model. Figure 6 shows the curves of the acceleration magnification factor with the elevation of the dam. As can be seen from Fig. 6, with the increase of elevation, the acceleration amplification was not obvious, and the peak response of the primary dam crest and sub-dam surface were basically the same. The seismic response at the sub-dam crest was enlarged slightly, but not significantly. The acceleration amplification factor showed a decreasing trend with the increase of input peak acceleration. This phenomenon was related to the increase of the

Fig. 6 Graph of acceleration amplification factor with elevation variation

shear strain, decrease of stiffness, and the increase of tailings sand damping (Wang et al. 2010). According to the research results of Song et al. (2016), when the shear strain γ_d increases gradually at the level of 10^{-5} – 10^{-3} , no matter it is biaxial consolidation or isobaric consolidation, the curve of damping ratio-shear strain begins to increase, and the tailings sand damping increases. With the increase of input peak acceleration, the tailings sand exhibited obvious nonlinearity, and its filtering effect gradually increased, this resulted in the decrease of acceleration amplification factor.

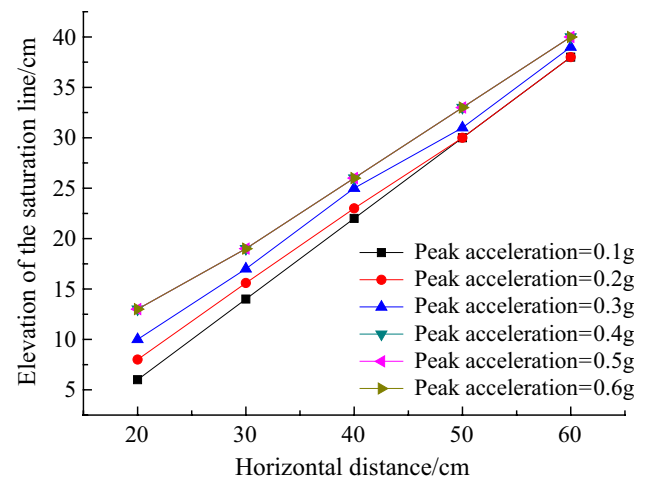
Fig. 7 Curve of the saturation line elevation with the input peak acceleration

The water level of the piezometric tube that was recorded in the test process is arranged into the variation curve of the saturation line with the input peak acceleration, as shown in Fig. 7. It can be seen from the figure that in the process of gradual increase of input peak acceleration, the saturation line gradually increased. Additionally, the lifting speed increased gradually with the increase of input peak acceleration; when the input peak acceleration reached 0.4g, the reservoir water level reached the highest level of dynamic loading, the sub-dam surface had a small amount of water precipitation, and liquefaction occurred locally in the dam body. Once the input peak acceleration increased again, the height of the saturation line remained unchanged.

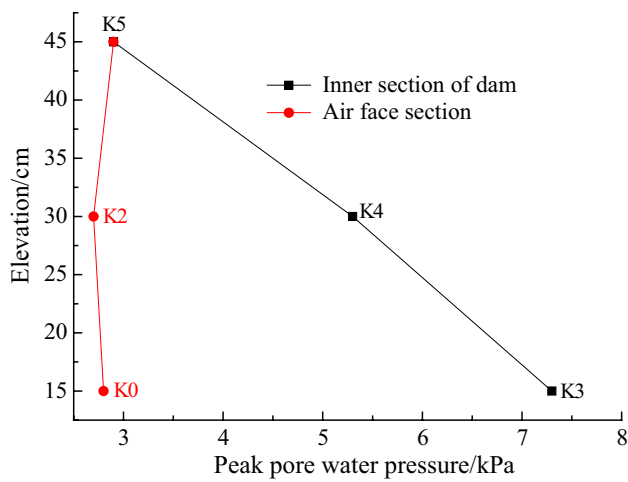
Fig. 8 Graph of pore pressure peak with elevation

Figure 8 shows the peak values of pore water pressure at the monitoring points around the slope face and the inner section of the dam in the case of input acceleration of 0.3g. It can be seen from the figure that the peak value of the pore pressure measured by the monitoring points near the air surface (K0, K2) was smaller than that at the inner section of the dam (K3, K4). However, once liquefied, the tailings dam may cause swamping or piping, and lead to dam damage.

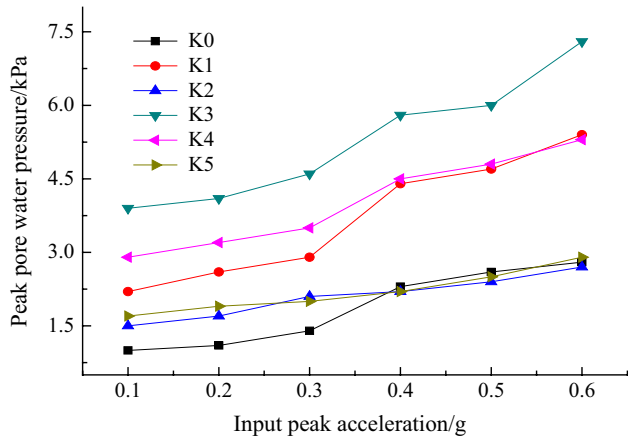
Fig. 9 Graph of pore pressure peak with acceleration peak variation

Figure 9 is the peak value of pore water pressure measured by 6 pore pressure transducers under different input peak acceleration conditions. It can be seen from the figure that the pore water pressure of the dam monitoring points increased with the increase of peak acceleration, and when the input peak acceleration reached 0.4g, the pore water pressure inside the dam basically remained unchanged, which indicated that the tailings had been liquefied. Under dynamic loading, the peak value of pore water pressure in the different positions of the tailings reservoir was different; the pore water pressure of the monitoring points in the lower row were larger, and the pore water pressure of the upper row of the monitoring points was smaller. However, the pore pressure ratio at the bottom row was smaller, and that in the upper row was larger. The pore water pressure inside the slope height was greater than that of the lateral, and the pore pressure ratio was smaller than the lateral

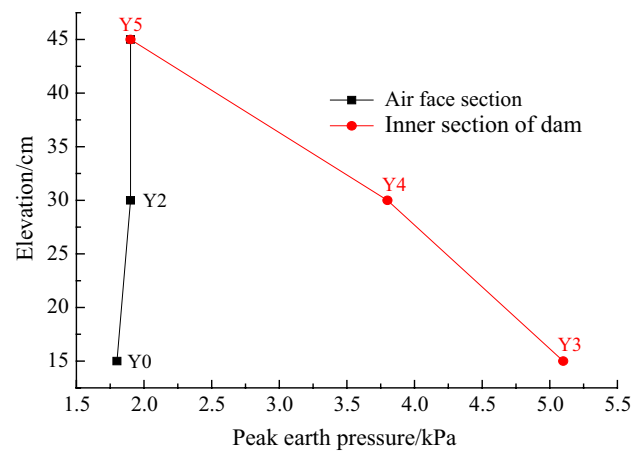
Fig. 10 Graph of earth pressure peak with elevation

Figure 10 shows the peak values of earth pressure at the monitoring points along the slope face and at the inner section of the dam. It can be seen from the figure that the peak value of the earth pressure measured by the 3 monitoring points near the air surface was smaller than that at the inner section of the dam.

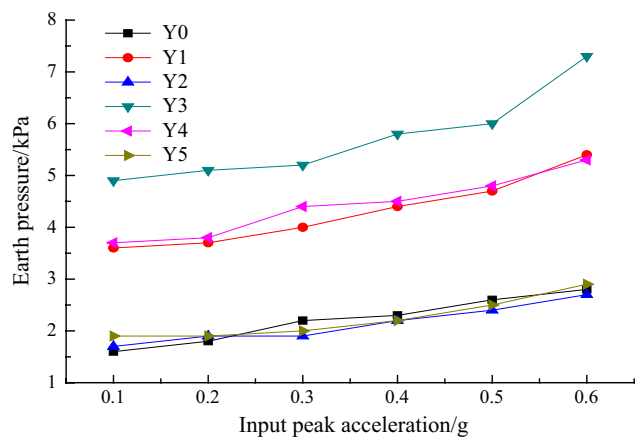
Fig. 11 Graph of earth pressure peak with acceleration peak variation

Figure 11 is the peak value of the earth pressure obtained by 6 earth pressure sensors under different input peak acceleration conditions. It can be seen from the figure that with the increase of the input peak acceleration, the peak value of the earth pressure of the monitoring point increased gradually.

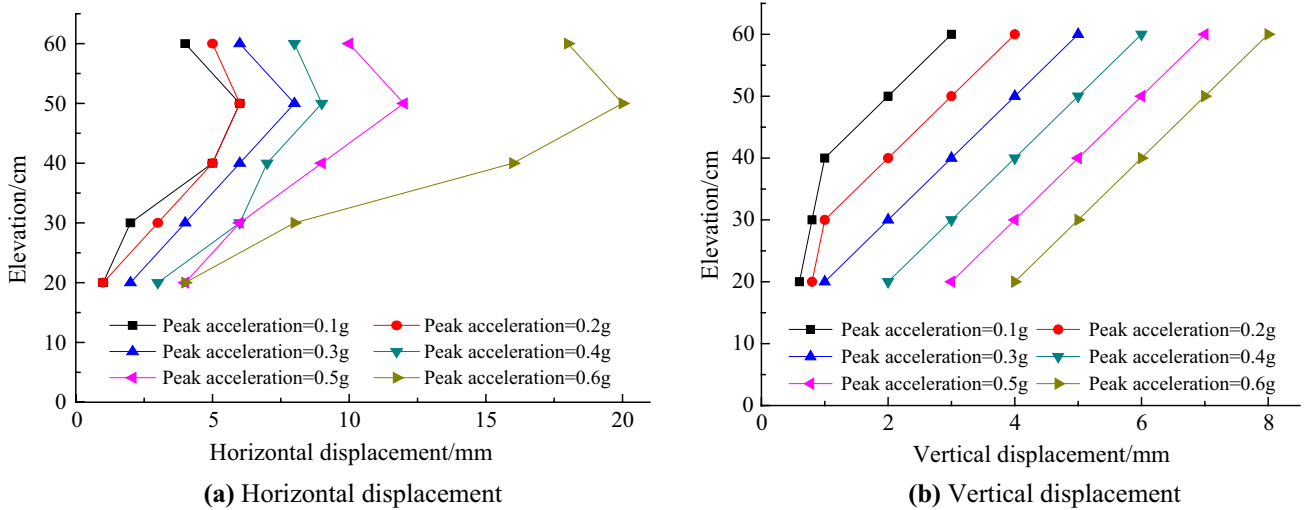
Fig. 12 Displacement curve of dam surface with elevation

Figures 12 and 13 are displacement curves of the dam surface with dam elevation and peak of input acceleration.

As can be seen from Fig. 12, for the input seismic wave peak value from 0.1 to 0.2g, the horizontal displacement of the tailings reservoir was relatively small, namely, 4 mm and 5 mm, respectively. When the input seismic crest value was from 0.3 to 0.4g, the deformation of the dam increased gradually, and the horizontal displacement of the dam crest reached 6 mm and 8 mm, which can be interpreted as the

deformation of the dam entering the plastic stage. As can also be seen from Fig. 12, when the peak acceleration was at 0.4g, an inflection point appeared on the curve, which indicated that the tailings dam suffered dynamic failure.

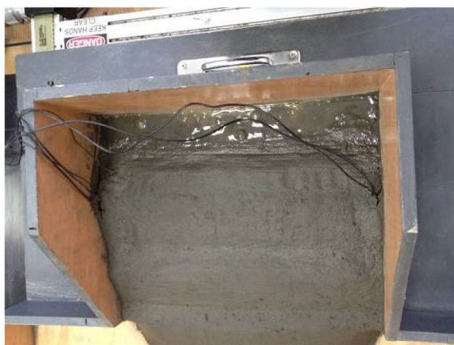
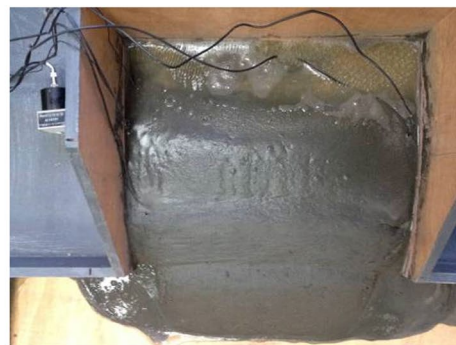
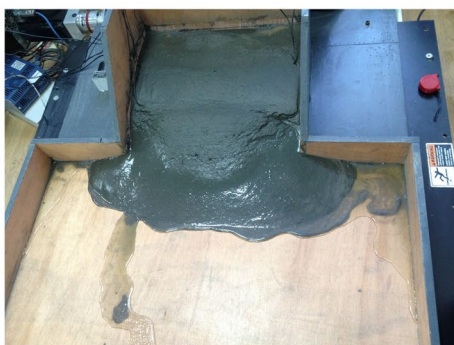
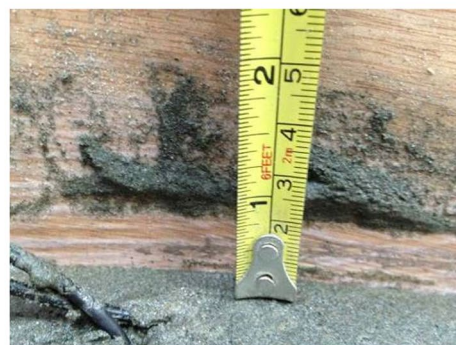
(a) Small amount of water being released from the dry beach

(b) Tailings mortar expanding at the toe of the tailings dam model

(c) Tailings expanding downstream

(d) Crest settlement after stopping vibration

Fig. 14 Macro-figures of dam-breaking process

The dam failure process of the tailings dam under dynamic loading is shown in Fig. 14. It can be seen from the figure that with the increase of vibration time, the liquefaction of the tailings began to appear, as shown in Fig. 14a, the water on the surface of the dry beach was precipitated, and the amount of precipitated water was continuously increasing;

as the vibration continued for a period of time, the contact area between the two sides of the model and the model box was destroyed. When the vibration continued, the liquefaction range expanded, pore pressure increased, shear strength of tailings sand decreased, sub-dam slipped, and large liquefaction occurred at the dry beach. Figure 14b shows that the failure occurred in the toe of the tailings model. The tailing sand was partially washed out from the lower part of the tailings dam with water, and resulted in the loss of tailings sand. The flow of tailings sand reduced the strength of the dam body. Figure 14c, d shows that the dam collapsed under the dynamic loading action, and the dam slid along the bottom of the dam. According to the existing failure mode, the tailings mortar in the tailings dam model diffused to the downstream after dam failure, and the vertical settlement of the dam crest reached 5 cm.

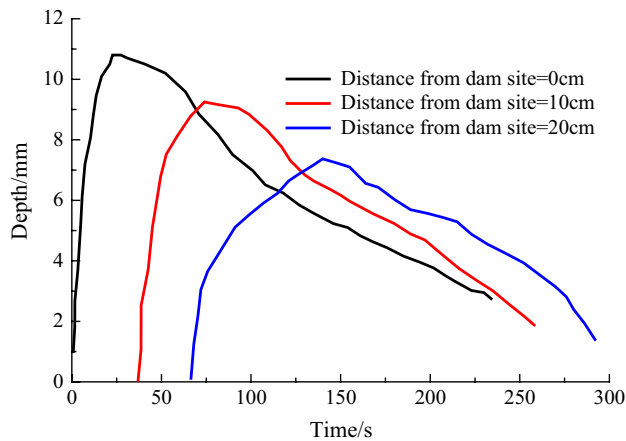
Fig. 15 Deep mud outburst evolution curve

Through analyzing the mud submergence elevation of the downstream cross section, the variation law of the mud depth time history and the mud evolution law of three typical sections were obtained, as shown in Fig. 15. When the mud reached the downstream cross section, the mud height increased rapidly to its peak value. With the mud evolving downstream, the mud height decreased gradually until the mud was stagnant. The entire mud submergence height

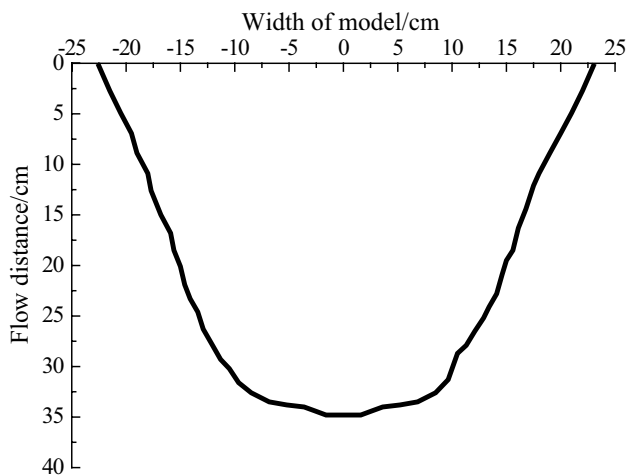
Fig. 16 Cross-sectional shape after dam failure

It can be seen from Fig. 16 that the final accumulation form of the dam was a semi-ellipse. The semi-elliptical long axis was along the direction of the tailings dam. Its short axis was along the direction of the tailings flow, and it was an accumulation fan slightly larger than half of the ellipse. The accumulation thickness of the tailings accumulation fan was thick in the middle, and gradually thinned at both sides to form a certain accumulation slope. The formation of the accumulation slope was caused by the viscosity of the liquid slurry in the tailings mortar and the friction resistance of the solid particles. The accumulation thickness gradually thinned from the front of the dam to the downstream and formed a certain accumulation slope. The final accumulation

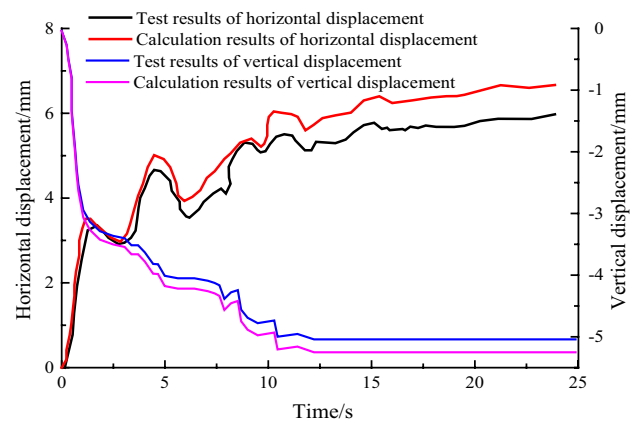
Fig. 18 Contrast of displacement time history curve

The calculation results of the crest displacement were compared to the test results, as shown in Fig. 18. As can be seen from the figure, the calculation results and the experimental results were consistent with the calculation results in the trend. The numerical calculation results were relatively large, in comparison to the test results, with the reason being that, when the test and calculation input the same seismic waveform, the actual acceleration of the table suffers a certain loss due to the impact of the load on the shaking table. That loss is smaller than the numerical value of input acceleration. Moreover, only the plastic deformation part could
